Manhole Inspection Summary

Manhole # S35SS1008MH

Insp Date: **2/19/07 2:59 PM**

Location Address: **401 NOTRE DAME LN**

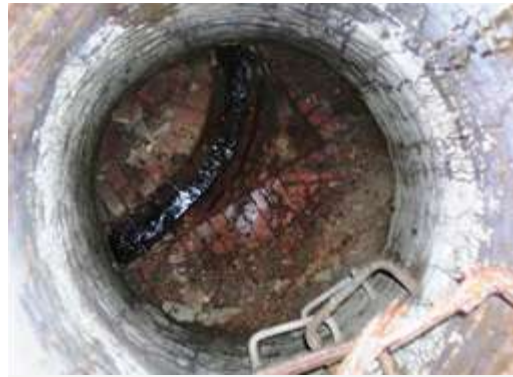
Top View

Corroded steps. Bench debris.

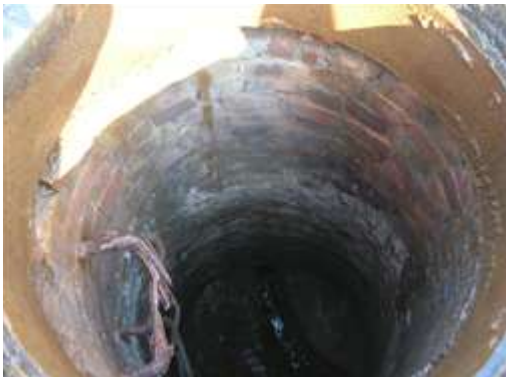
Defect

Frame Offset: **0** (in.) Condition: ☐ Sound ☐ Cracked ☒ **Leaks**

Condition: ☐ Sound ☐ Cracked ☐ Root Intrusion ☒ **Loose Brick** ☒ **Deteriorated**

Infiltration: ☐ None ☒ **Joint** ☐ Cracks ☒ **Mortar** ☐ Roots ☐ Wall

Infiltration: ☐ None ☐ Joint ☐ Cracks ☒ **Mortar** ☐ Roots ☒ **Wall**

Frame leaks. Adjustment loose brick, deterioration and infiltration. Corbel and Barrel infiltration - other side.

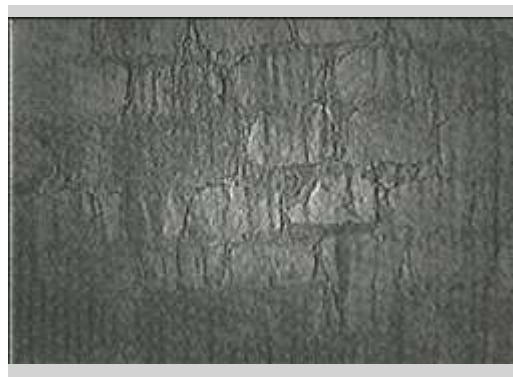
Defect

Condition: ☐ Sound ☐ Cracked ☐ Root Intrusion ☐ Loose Brick ☒ **Deteriorated**

Infiltration: ☐ None ☐ Joint ☐ Cracks ☒ **Mortar** ☐ Roots ☒ **Wall**

Barrel deterioration and infiltration.

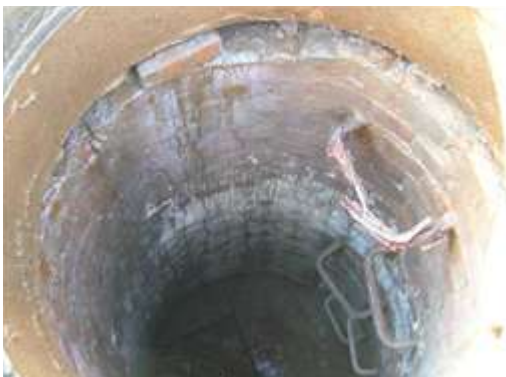
Defect

Frame leaks. Adjustment loose brick, deterioration and infiltration. Corbel and Barrel infiltration.

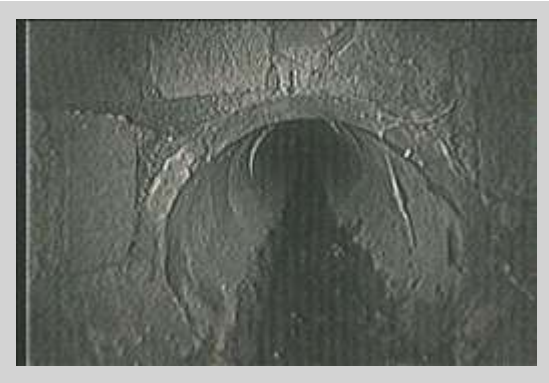
8 in. Circular Gravity Sewer Pipe Out @ 12 O'Clock

Infiltration: **Evidence** Pipe Seal Cond: **Cracked**

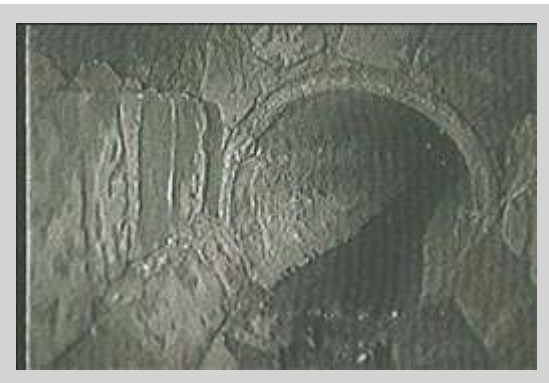
8 in. Circular Gravity Sewer Pipe In @ 8 O'Clock

Channel deterioration.

Infiltration: **None** Pipe Seal Cond: **Cracked**
